DATE: May 23, 2011

SERVICE BULLETIN #20110523

SUBJECT: Inspection of the top diagonal attachment point on all Vector 3 Sport and SE Student Harness/Container Systems.

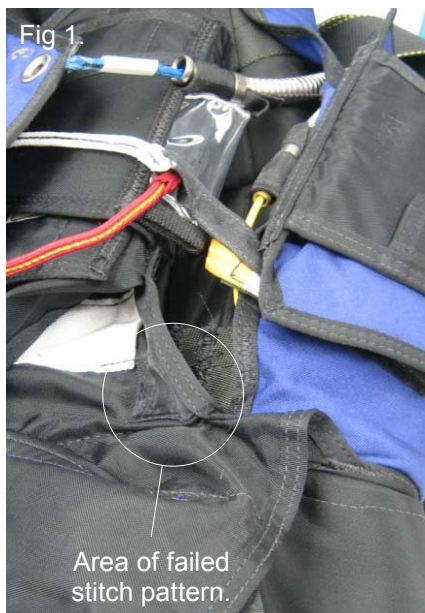
BACKGROUND: It was reported that a student jumper after pulling at a planned altitude of 5000', experienced a very hard opening and broke the upper double zigzag stitching that holds the diagonals in place and tore most of the ring cover off (See Fig1). This allowed the large ring riser attachment to be pulled far away from its normal position, deforming the over the shoulder section of padding and in turn pulled the RSL lanyard releasing the reserve pilot chute.

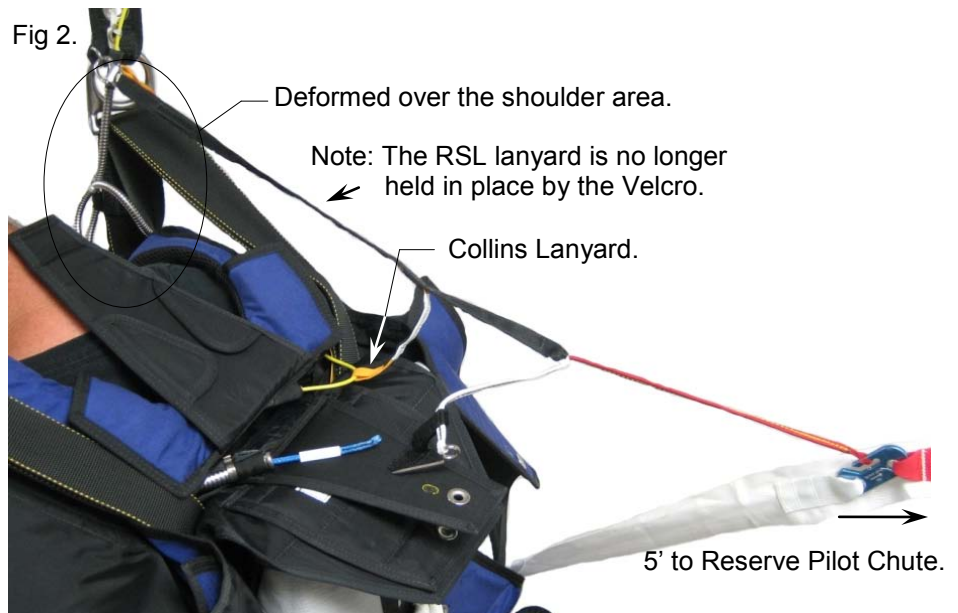
At an altitude of around 4500' the attachment point of the SkyHook and RSL lanyard produced a trailing reserve pilot chute (*preventing a two out scenario*) as witnessed from the ground (See Fig2). At an altitude reported to be between 225' and 250' the student jumper initiated a final approach turn, but due to the deformation of the right shoulder section of the harness, the Collins lanyard released the left riser from this turn input (See Fig2). The student then reacted by immediately pulling the cutaway handle releasing the right riser initiating a SkyHook direct bag deployment. After a very short reserve canopy ride, the student experienced a hard landing in a corn field.

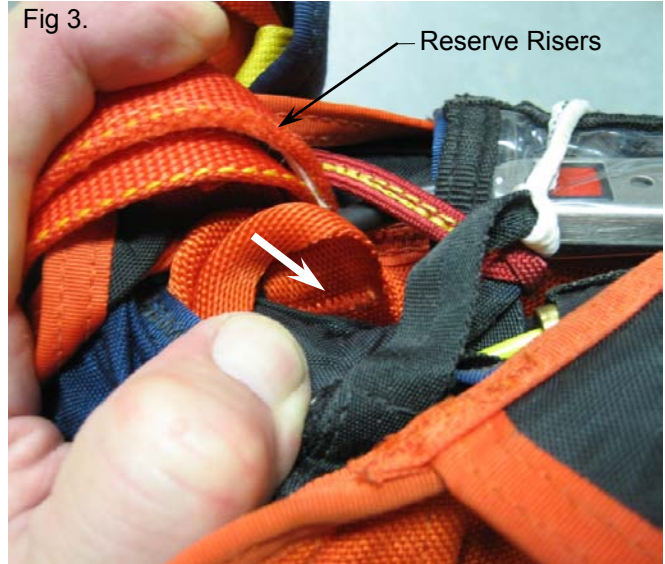
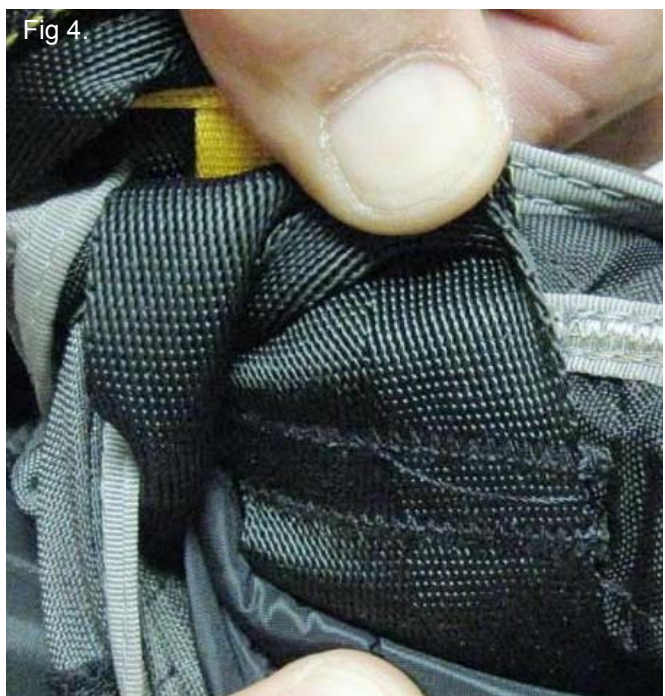
Figures 3 and 4 show examples of undamaged stitch patterns. Undamaged stitch patterns such as these do not require repair.

**SERVICE BULLETIN:** Before the next jump it is strongly recommended that all jumpers inspect this area for broken stitching. This can easily be done on packed rigs by simply opening the reserve pin cover and riser cover, then work your thumb up under the diagonal to expose the zigzag stitching. Only the top inside section of stitching needs to be inspected (Figure 3). Consult your local rigger if you are unsure or have any questions.

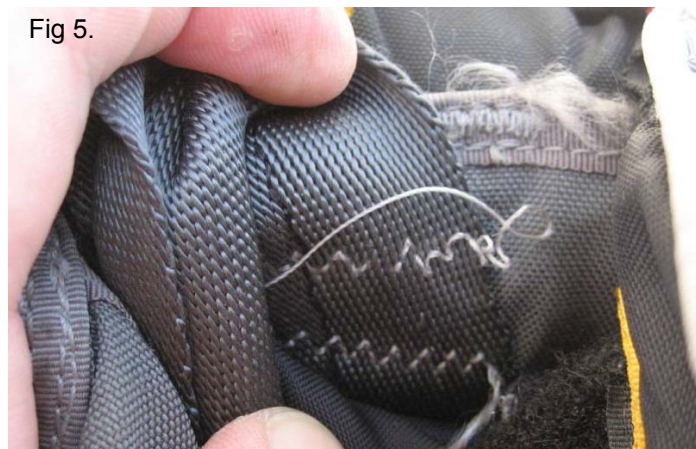
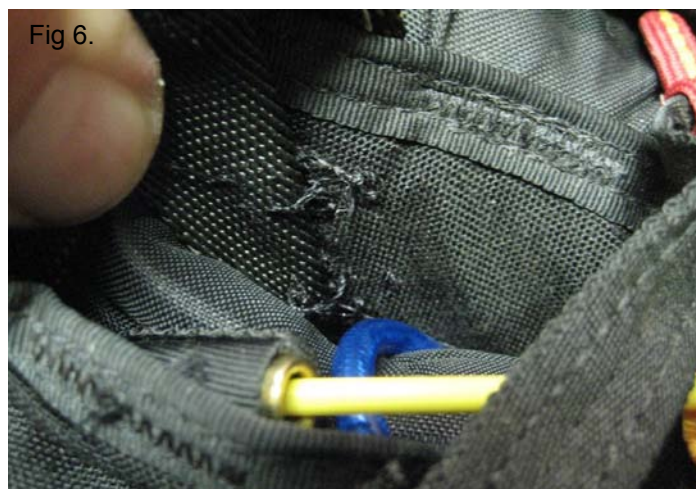
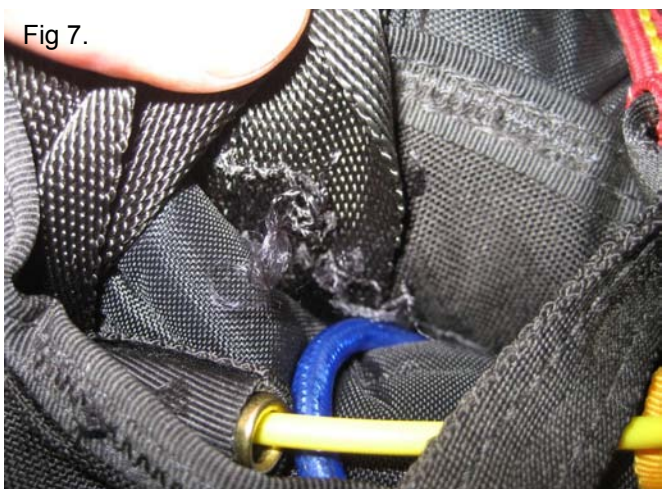
Figures 5, 6 and 7 show example of failing stitch patterns in need of repair.

If the diagonals are in need of repair, riggers in the field are now authorized and requested to make this zigzag repair using “E” shape stitch pattern. This “E” shape zigzag stitch pattern is the same pattern that has been in use on the Sigma Tandem system for some time.
