## SAFETY NOTICE

No. 14-01

<b>To:</b>	All Parachute Technicians		
<b>Re:</b>	Unapproved Repairs and Modifications		
<b>Compliance:</b>	Informational		
<b>Compliance Due:</b>	Ongoing	<b>Date of Issue:</b>	24 Feb 2014

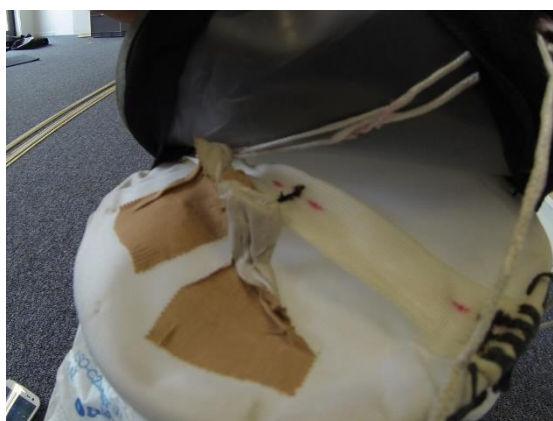
Recently during a routine repack, a Racer Elite reserve pilot chute was found with several tacking stitches missing from the cap, and some kind of sticky tape underneath the cap (Elastoplast or similar). The tape appears to have been used to hold the closing loop in place, instead of tacking it down as required by the manufacturer.

This practice is not in accordance with approved repair/modification procedures for this equipment (and not effective either, as evidenced by the way the tape has bunched up and not held the loop in place at all). Furthermore, the introduction of non-conforming materials into the reserve assembly voids the equipment's TSO, which can have far-reaching legal as well as safety consequences.

All this is to say: be ever-vigilant in your gear inspections, and EXTRA-thorough when inspecting equipment that has previously been maintained by someone whose work you are unfamiliar with.
